# Esprit Positioning System

## Inspecting the Esprit Pedestal Plate (EPP) on the Esprit Positioning System™

### Instruction Bulletin

CI8D-424

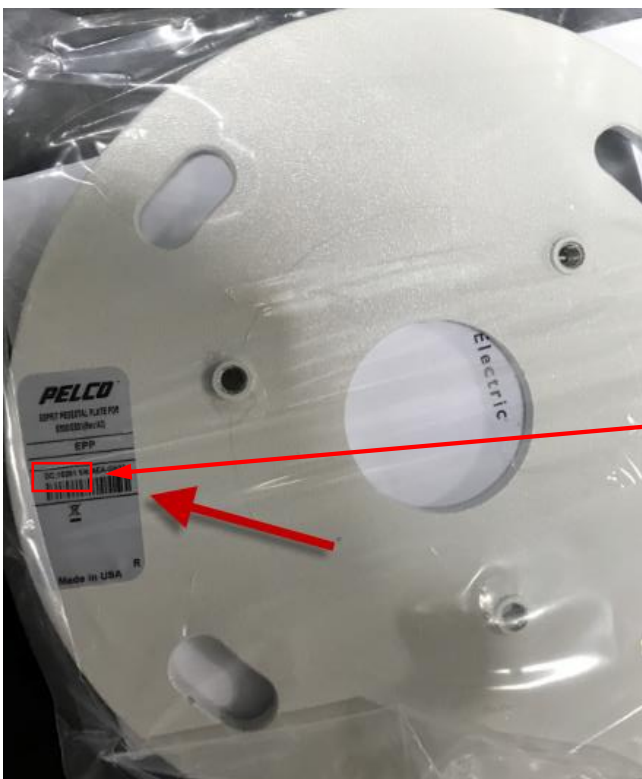
- Find the Date Code on the EPP unit.

DC: XXYY  
XX = Year  
YY = Day of Year

- If EPP has Date Code 14226 or older
  - Please visit the EPP offer safety alert site at [www.pelco.com/quality#osa](http://www.pelco.com/quality#osa) and fill out the provided form to request EPP2 (Stainless Steel) plates as needed.

- If your Esprit Pedestal System is in a marine environment, replace your EPP with a new EPP2 plate.
  - If your Esprit Pedestal System is not in a marine environment, inspect your EPP for any corrosion. If no corrosion is present, continue your preventative maintenance on the unit.

- If EPP has Date Code 14226 - 16138
  - Please visit the EPP offer safety alert site at [www.pelco.com/quality#osa](http://www.pelco.com/quality#osa) and fill out the provided form to request Stainless Steel EPP plates as needed.

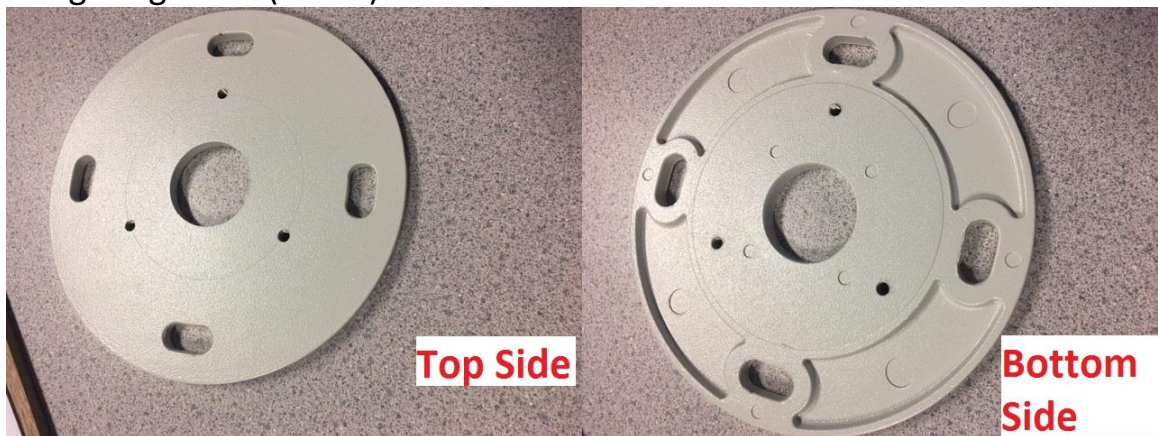
- Inspect your EPP to confirm whether the plate is installed correctly. The smooth side should be facing the Esprit System (Up) while the side with grooves should be facing the ground (Down).

- If your EPP is mounted correctly, please continue to implement your preventative maintenance plan. No replacement required.
- If your EPP is mounted incorrectly, please rotate the plate to the correct orientation.
- If your EPP is damaged regardless of mounted orientation, please replace the plate with a new EPP2 plate.
